RESERVOIRS

The chapter on Masonry Dams has been increased twofold by an attempt to make some mention of all the most notable dams of the world, and many that are very little known. Attention is particularly directed to Plates 1, 2, and 3, in which profiles are shown of all of the leading and better known masonry dams in existence, drawn to uniform scale for easy graphical comparison. No such complete collection of dam profiles has ever before appeared in print, assembled together on a common basis.

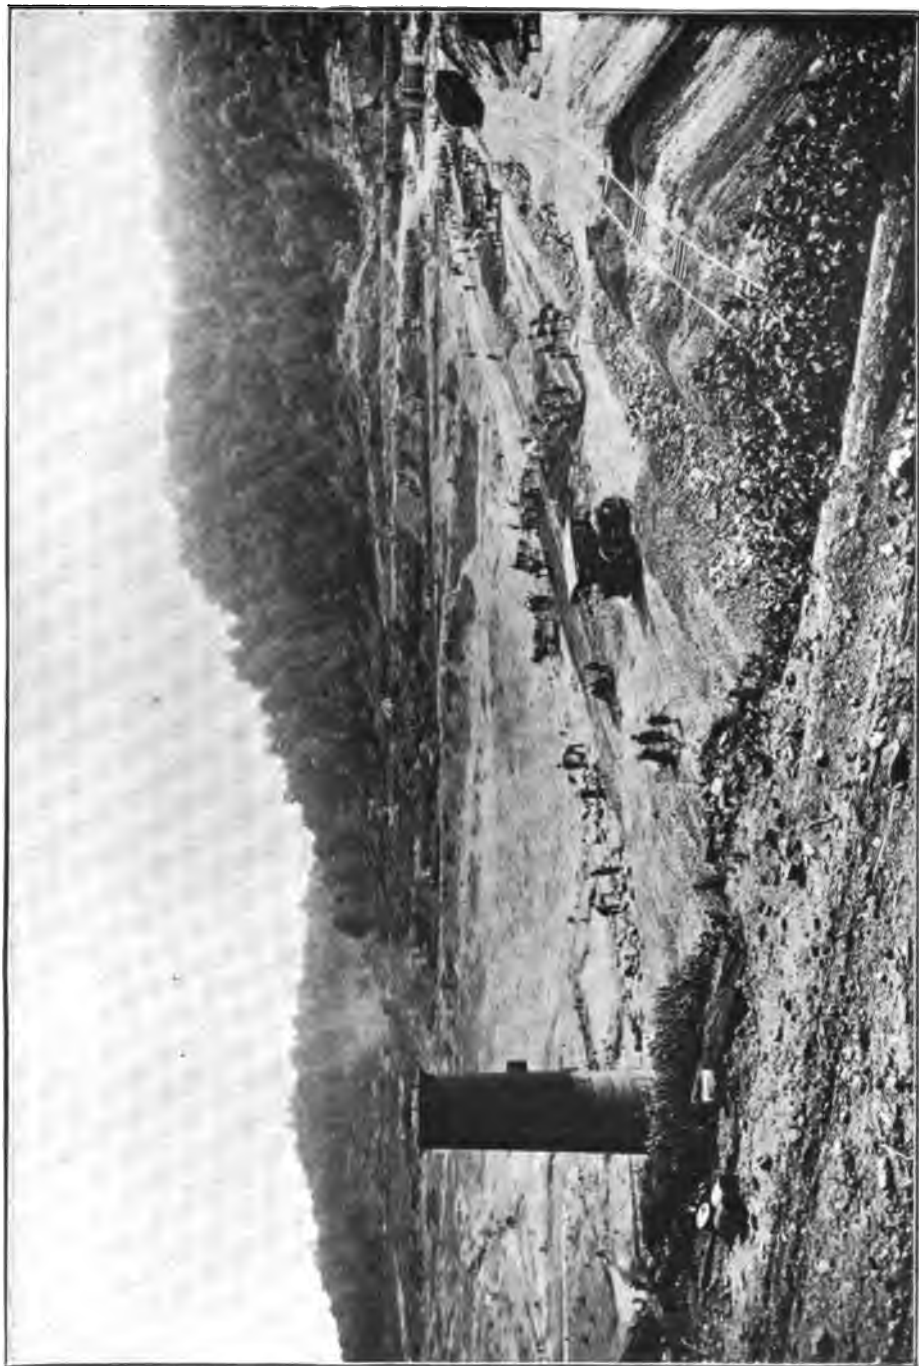
FIG. 359.—ILLUSTRATING THE STEEL OUTLET TOWER AND METHODS OF CONSTRUCTION OF THE HINKSTON RUN CINDER-FILL DAM,
JOHNSTOWN, PA.

It is essentially an earth embankment with concrete core-wall extending from bed-rock up to about one-third the height, or 45 feet below the water-line. The unique feature of the dam is the heavy reinforcement given to it by a backing of cinders, the waste product of the blast-furnaces of the Cambria Steel Works. This cinder-fill is to eventually give the dam a minimum crest width of 500 feet. It is now 300 feet wide at the minimum, and 1000 feet at the widest place. The illustration, Fig. 360, gives a clear idea of the plan of construction. The dimensions are as follows:

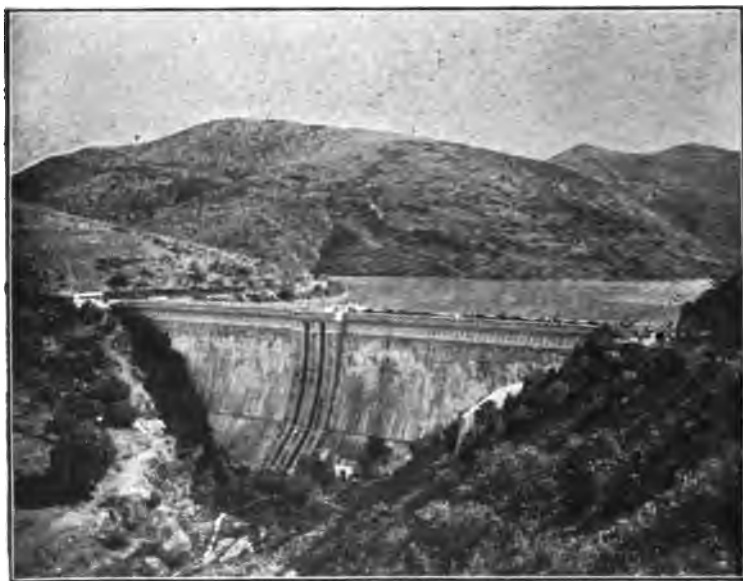
FIG. 362.—GENERAL VIEW OF THE ESPERANZA DAM AND RESERVOIR, NEAR GUANAJUATO, MEXICO.

An excellent general view of the dam and its reservoir of 462 acres is given by the accompanying cut, Fig. 362, which shows the three buttresses, each 9.87 feet square, which extend from bottom to top. These were designed as an ornamental feature, primarily, but serve to

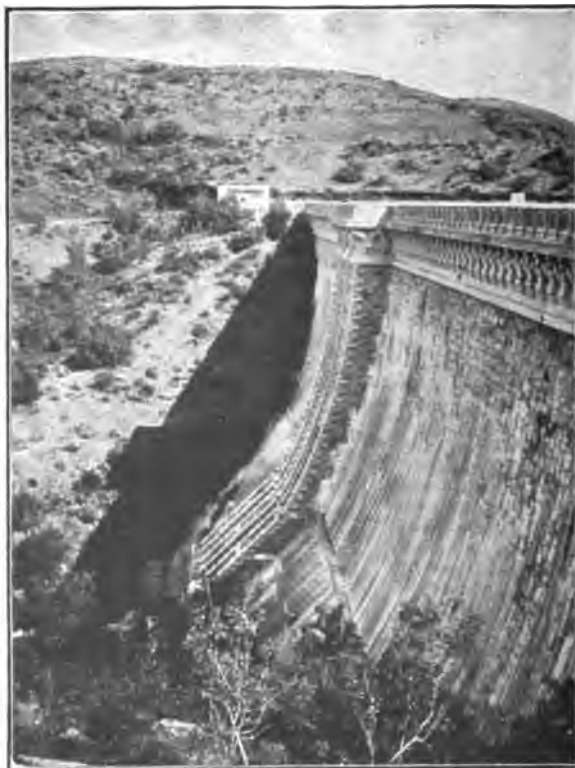
FIG. 363.—THE ESPERANZA DAM, MEXICO, LOOKING ALONG THE EXTERIOR FACE.

add somewhat to the stability of the structure. They certainly are effective from an architectural point of view. Fig. 363 conveys a still better idea of the details of the ornamentation given to the dam by the trimmings of these buttresses, and the decorative cornice in cut stone.

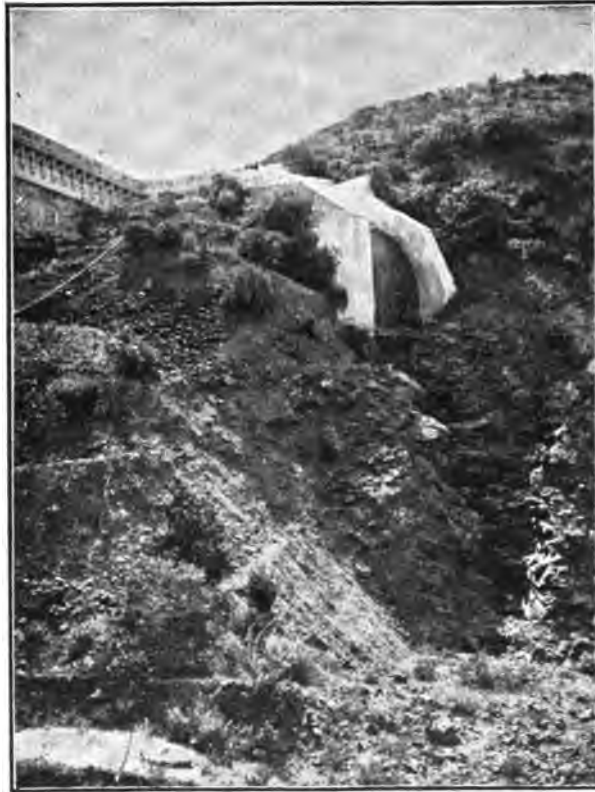
FIG. 364.—DISCHARGE END OF SPILLWAY, ESPERANZA DAM, GUANAJUATO, MEXICO.

Spillway.—The spillway is located at the south end, or left bank, and is stated to have a capacity of 1765 second-feet. Its discharge end is shown by Fig. 364. It passes through the dam by a channel which is

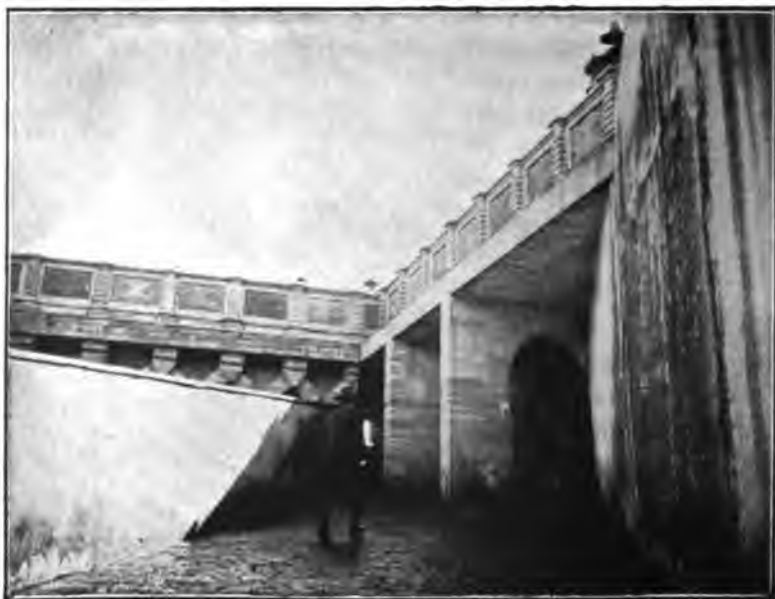
FIG. 365.—THE SPILLWAY CHANNEL OF THE ESPERANZA DAM, AT ITS UPPER END, SHOWING OBSTRUCTIONS TO FREE DISCHARGE BY PIERS SUPPORTING ROADWAY.

somewhat obstructed by the masonry piers supporting the roadway on the top of the dam, as seen in Fig. 365.

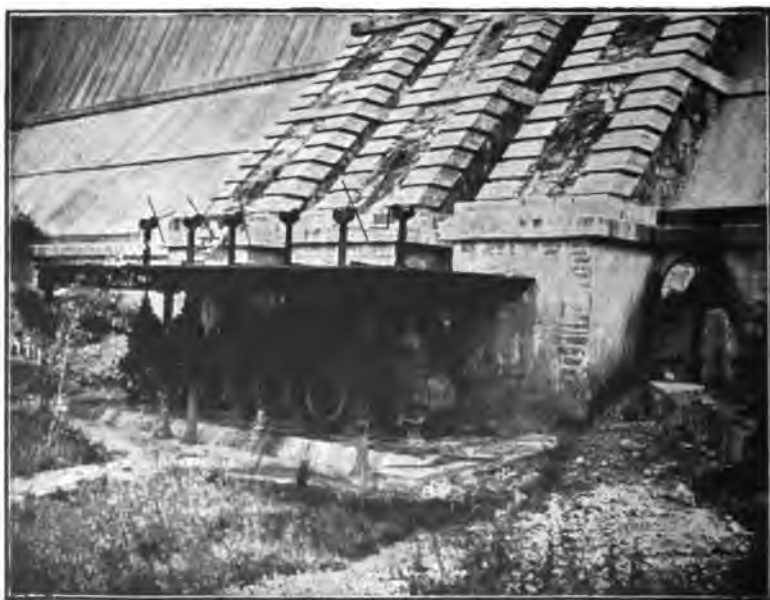
FIG. 366.—THE SIX OUTLET PIPES AND GATE-VALVES OF THE ESPERANZA DAM, BEFORE CONNECTION WITH WATER MAINS OF CITY.

The outlet-gates of the reservoir are six in number, located under the buttresses. They each have a clear diameter of $28\frac{1}{2}$ inches, and are controlled by gate-valves operated by hand windlasses, as shown by Fig. 366. They are in sets of three, each set being attached to one of two wrought-iron pipes, 4 feet 6 inches in diameter, which pass through the masonry of the dam.

The gates are wholly unprotected, except by a light wooden-platform which serves merely as a means of access to the operating mechanism. Any injury to the gates would have disastrous consequences, as they cannot be repaired or adjusted except by wholly emptying the reservoir.

The small pipe shown in the angle between the buttress and the dam is a cast-iron pipe $15\frac{1}{2}$ inches outside diameter, which passes through a tunnel in the dam to a standpipe in the reservoir. This standpipe has seven openings from the reservoir, at varying levels, each controlled by a separate valve which is operated by mechanism mounted on a tower reached by a bridge from the center of the dam. This appears to be the main supply-pipe to the city, and its exposed condition is a matter of remark.

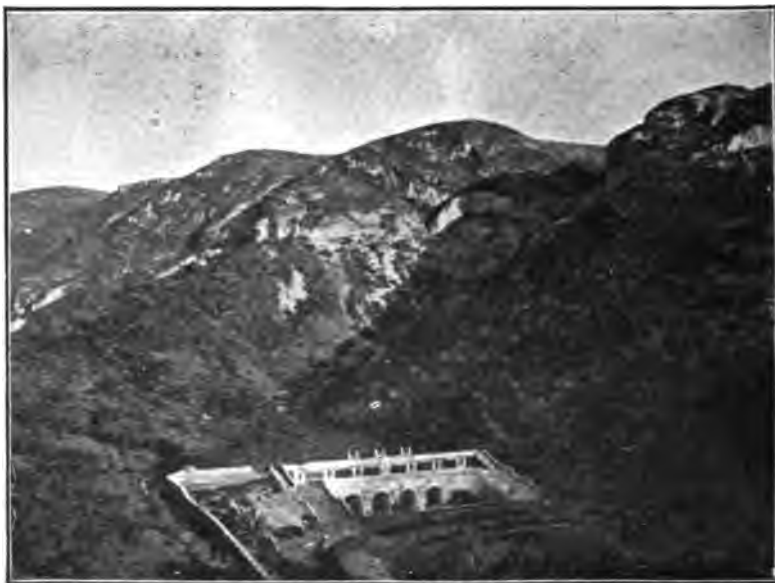
FIG. 367.—THE UPPER OLLA DAM, GUANAJUATO, MEXICO.

Fig. 367 is a distant view of the Upper Olla dam, while Fig. 368 shows the Lower dam, both of which combine many architectural effects with their utility as storage dams. The crest of each serves as a promenade as well as a flood-discharge spillway. A small volume of water wasting passes under the footway without flooding the crest, while a larger discharge passes over the footway. In either event the waste waters pass into a pit close to the down-stream toe of the dam, and out through a tunnel under the park to a lower point of discharge into the stream-bed.

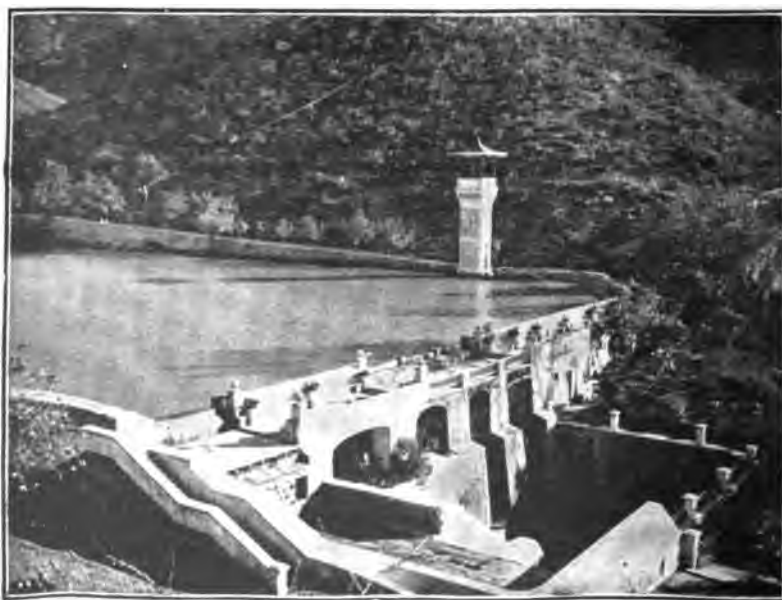
FIG. 368.—THE LOWER OLLA DAM, GUANAJUATO, MEXICO. (See also frontispiece.)

due to the fact that the up-stream face is a wooden barrier of flash-boards, removable in times of extreme flood.

The width of the lower dam at the crest is 19 feet, and its length about 300 feet. An angle of 45° down stream exists in the alignment of the lower dam.

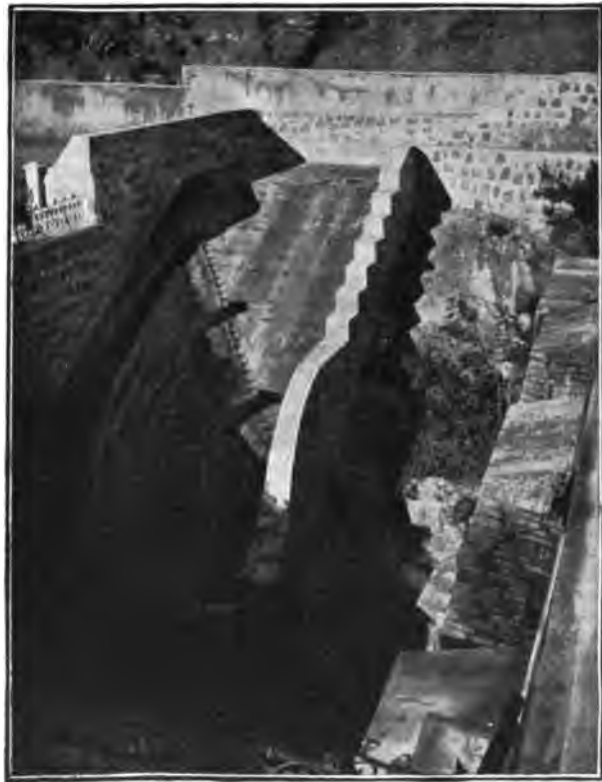
FIG. 369.—SPILLWAY CHANNEL OF THE LOWER OLLA DAM, GUANAJUATO, MEXICO.

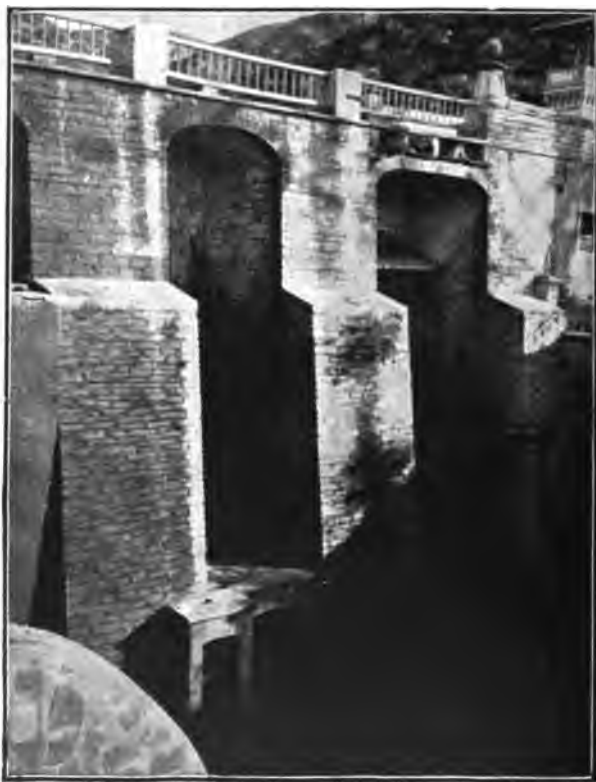
FIG. 370.—A DETAIL OF THE DOWN-STREAM FACE OF THE LOWER OLLA DAM, GUANAJUATO. These openings are closed by a form of movable flash-board.

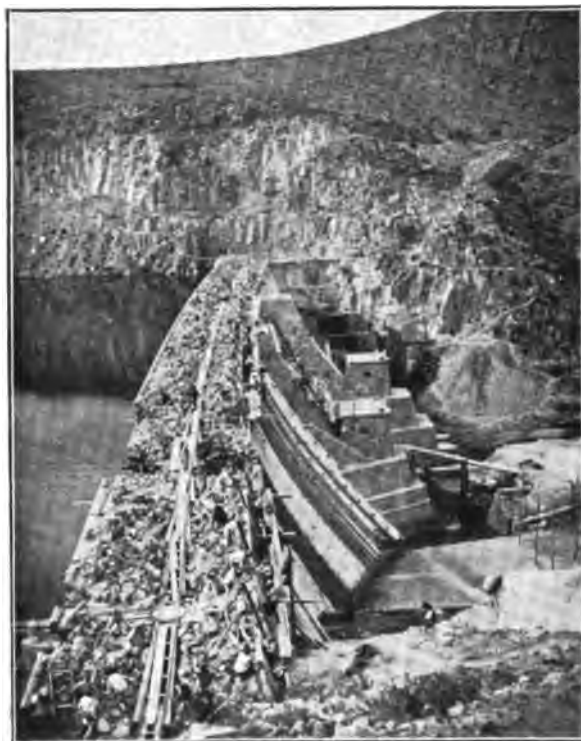
FIG. 371.—GENERAL END VIEW OF THE PRESA DE SAN JOSÉ AT SAN LUIS POTOSÍ, WHILE UNDER CONSTRUCTION.

The San José Dam, San Luis Potosi, Mexico.—In 1901, at the time the photographs shown in Figs. 371, 372, 373, 374, and 375 were taken, a private company was engaged in building a high masonry dam for the storage of water to supply the city of San Luis Potosi and to irrigate land in its vicinity. The city is a stockholder in this corporation. The dam as subsequently completed has an extreme length on the crest of 592 feet, and a maximum height of 151 feet from the lowest foundation to the crest, or 110 feet from the stream-bed to the top. Its thickness at the base is 128 feet, and at the crest about 15 feet.

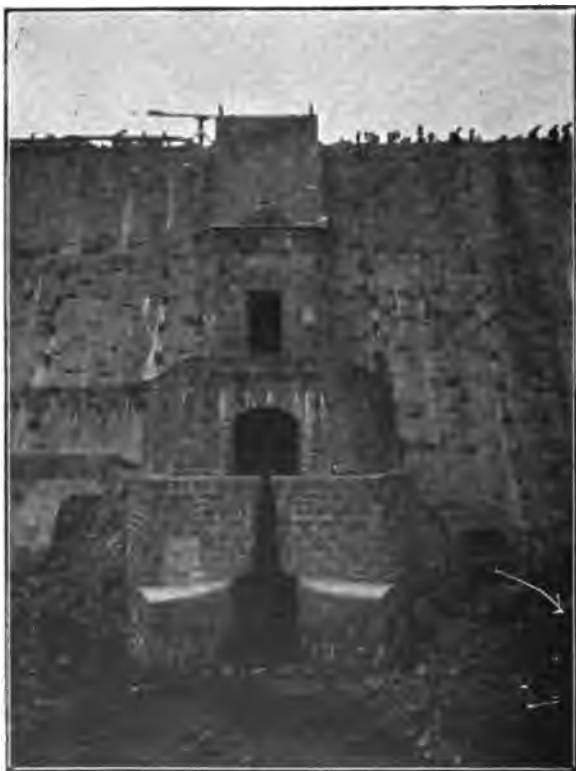
FIG. 372.—ONE OF THE TWO GATE-HOUSES OF THE SAN JOSÉ DAM, SAN LUIS POTOSI, MEXICO.

adding to the architectural effect. The lower part of one of these is shown in Fig. 372. They are massive and of generous dimensions. One of them was designed to be surmounted by a statue of a lion on a pedestal.

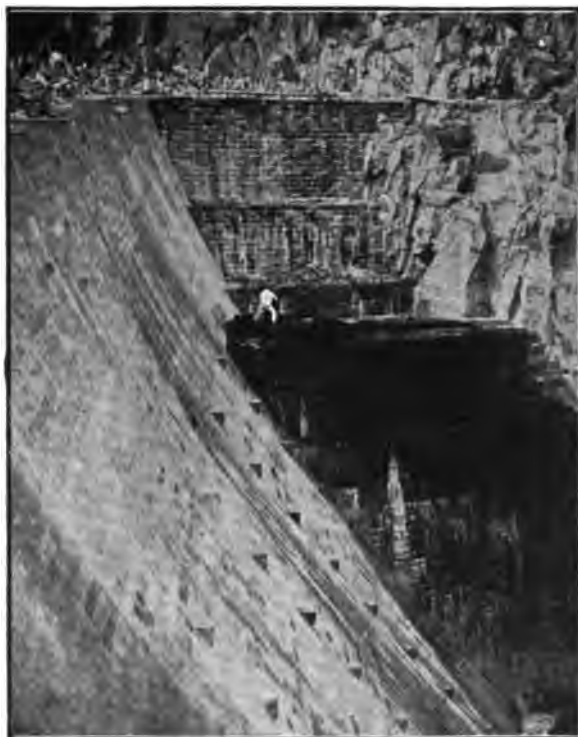
FIG. 373.—LOOKING ALONG THE FACE OF THE SAN JOSÉ DAM, AT SAN LUIS POTOSÍ, SHOWING FACE OF WALL SUPPORTING SIDE OF PRINCIPAL SPILLWAY.

bank has a maximum width of 86 feet, tapering to 36 feet in a length of 65 feet. The supporting side wall of the larger spillway is shown in Fig. 373.

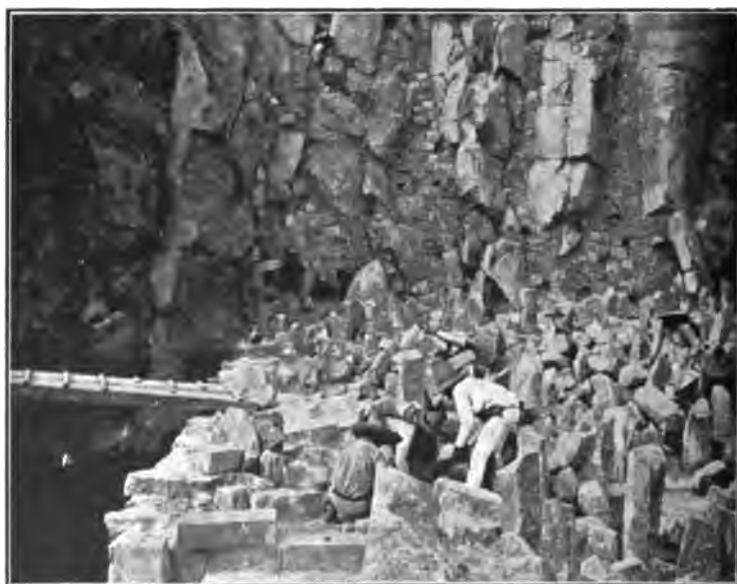
FIG. 375.—ILLUSTRATING THE BONDING OF THE MASONRY OF THE SAN JOSÉ DAM
MEXICO.

the base on the up-stream side, and near the top on the down-stream face. In plan the dam is slightly curved up stream with a radius of 2000 metres (6560 feet). It is built of uncoursed rubble masonry, with no stone larger than two men can conveniently carry and mostly of one-man-stone. The bonding of this rubble with long vertical headers is clearly shown in Fig. 375. The two faces are laid in well-cut stone.

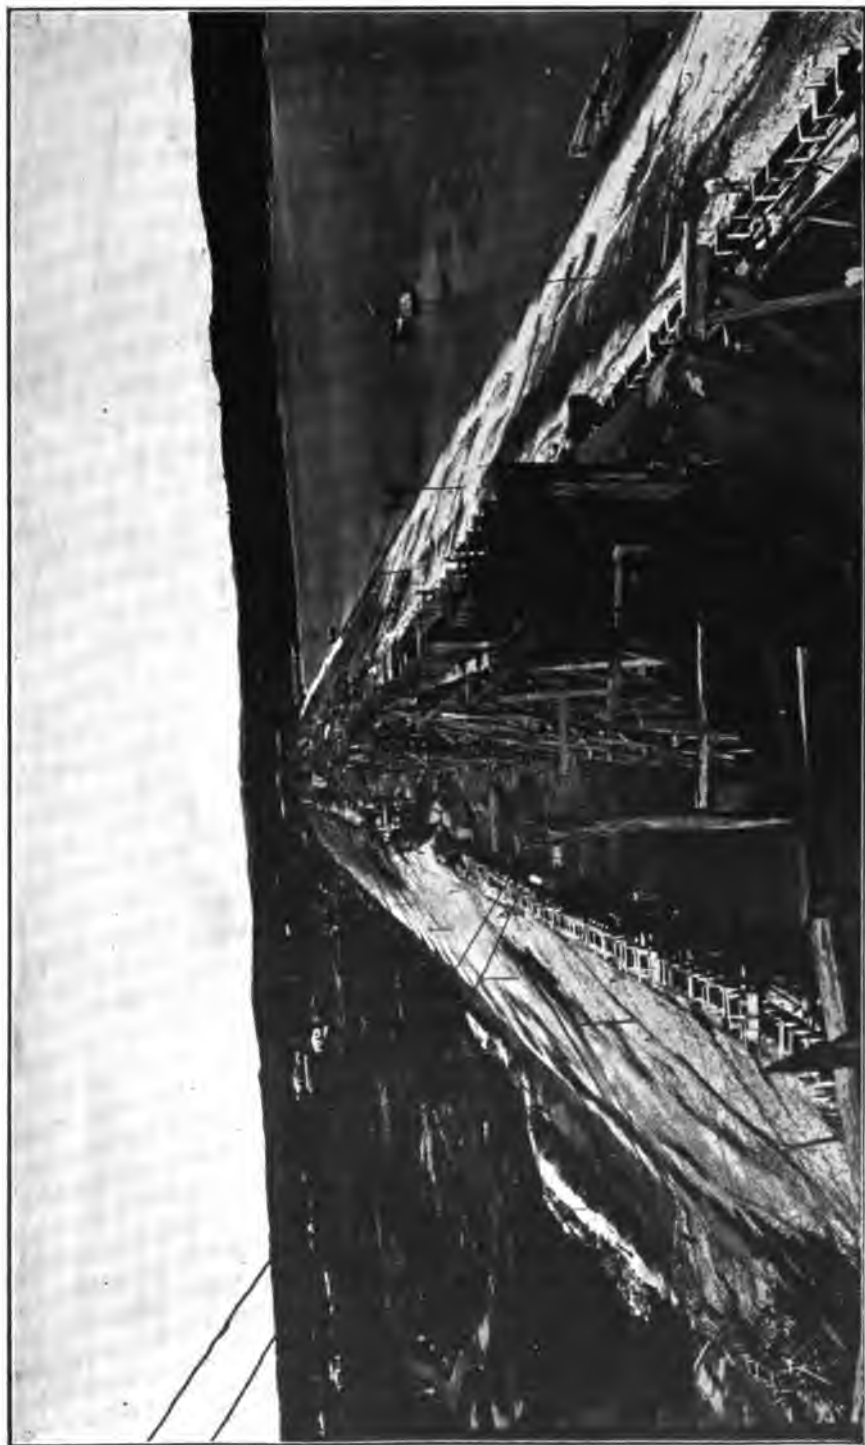
FIG. 376.—THE SANTO AMARO DAM, BRAZIL, APPROACHING COMPLETION, MARCH 3, 1908.

The Santo Amaro Dam, Brazil.—At the end of May, 1908, there remained but 18,600 cubic yards of this great dam to complete it, out of a total of 737,539 cubic yards. The photograph, Fig. 376, was taken March 3d, from practically the same point of view as Fig. 105, page 146, and shows the dam well along toward completion. The progress made in the construction of this dam as summarized in the semi-monthly reports, constitutes a most interesting record of that class of work, which is here presented in tabulated form, as the most complete and continuous record of the work accomplished by a given quantity of water in hydraulic sluicing that has even been published:

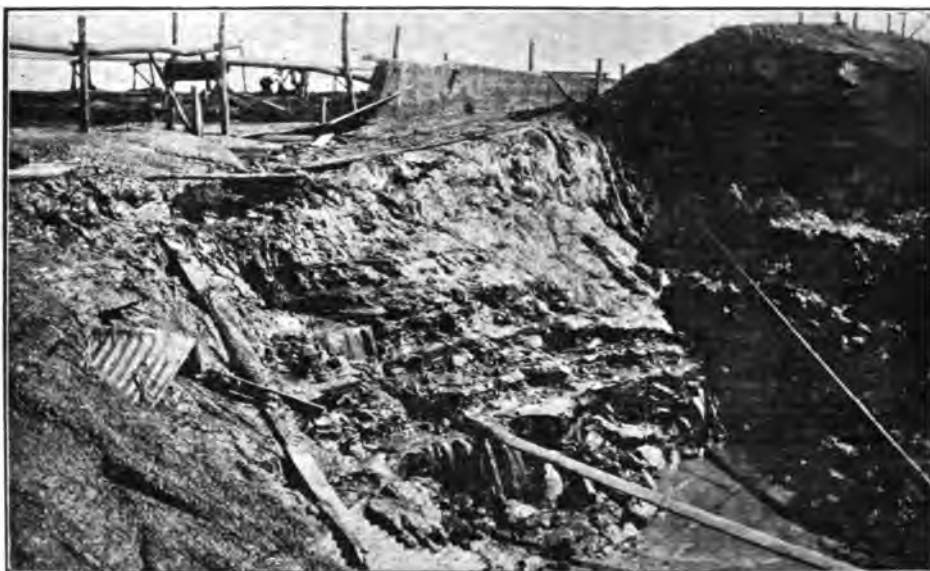
FIG. 377.—ILLUSTRATING THE COMPACT CHARACTER OF THE CLAY CORE OF THE SANTO AMARO DAM, ACCIDENTALLY EXPOSED TO VIEW BY A BREAK FROM THE POND ON TOP OF THE DAM.

The remarkable picture shown in Fig. 377 is the best possible demonstration of the effect of hydraulic sluicing in the segregation of pure clay from a mass of coarser materials, and its deposit in a condition of stable solidity within a short time. It is a picture of the clay core of the Santo Amaro dam accidentally exposed to view by a break in one of the lateral levees, the effect of which was to empty the pond on the dam and wash

away the levee and its supporting base of coarser material for a distance of about 50 feet. The break, which occurred in the up-stream slope, caused the loss of 400 cubic yards of material, but the demonstration of the stability of the clay core, none of which had been deposited three months, and some of it but a few days, was worth far more than the loss. The clay as exposed was left standing almost vertically, and it had successfully withstood the wash of water pouring over it from the emptying of a pond several hundred feet long, 50 to 60 feet wide, and 2 to 4 feet deep, with comparatively slight erosion. The break was caused by the saturation of the levee, built of material brought in by cars, which, not being sluiced and assorted, the finer particles from the

The conditions of solidity and maturity in the clay core shown in this case is a most reassuring endorsement of the superiority of the hydraulic sluicing method of dam construction.
